Final  
Report

March 1972

# Composite Overwrapped Metallic Tanks

1. Report No. NASA CR-120888		2. Government Accession No.		3. Recipient's Catalog No.	
4. Title and Subtitle COMPOSITE OVERWRAPPED METALLIC TANKS				5. Report Date March 1972

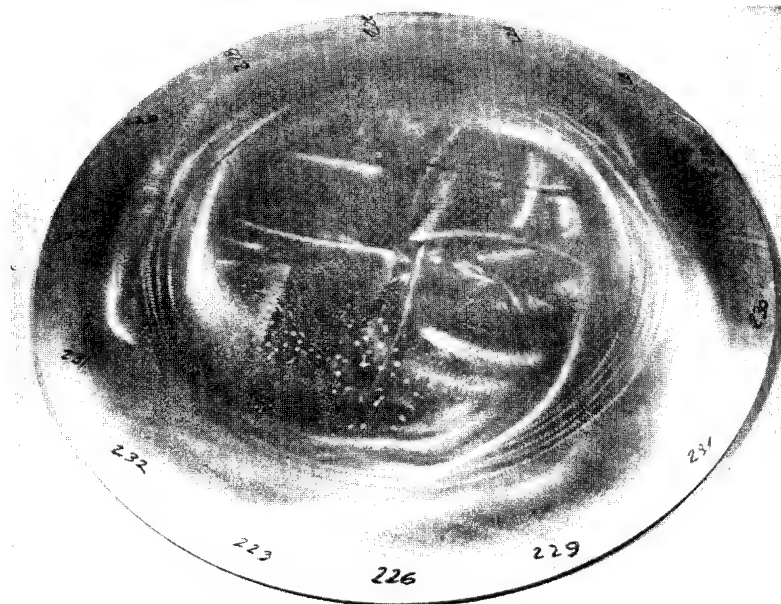
The raw material as received from the supplier contained numerous surface defects and, even though bought to commercial standards, part of the shipment was returned to the supplier for poor workmanship. The variations in flatness from the edge to the center of a sheet, though within specification requirements, made it very difficult to work in the explosive-forming process. Attempts to machine the surfaces to a close tolerance were not successful because of the inability to hold the material flat. In general, it is concluded that the poor quality of the material (see Section B) had a major bearing on the program's lack of success (Fig. 3, 4, and 5).

Figure 3 Explosive-Forming Titanium Blank Showing  
Rolled-In Defects and Surface Pitting Remaining  
After Attempts to Grind the Surface under a  
Coolant

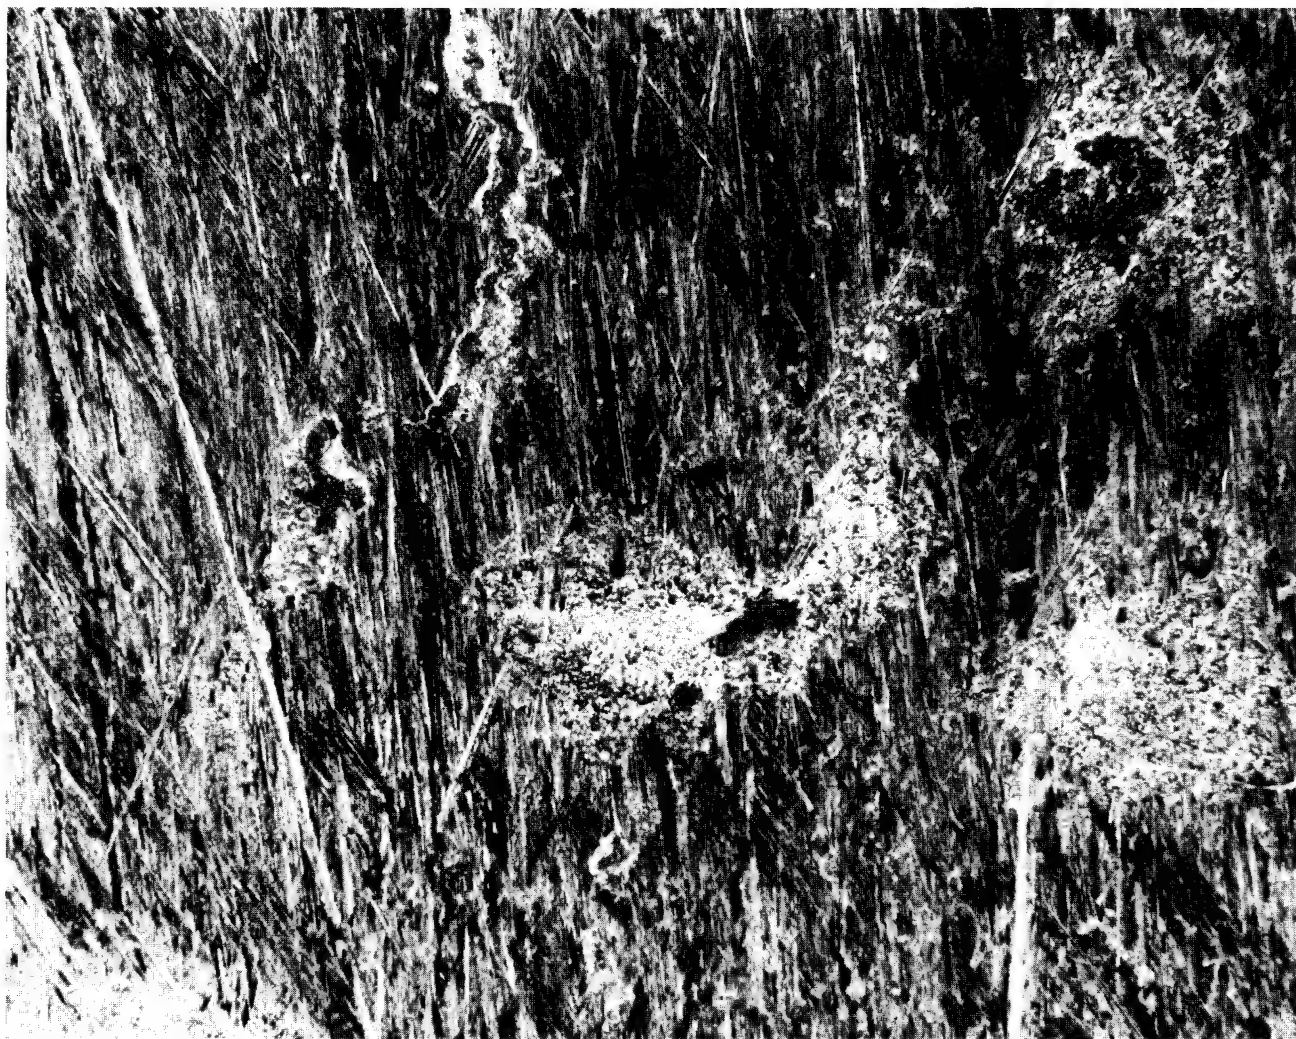
Figure 4 Macrophotograph (Approximately 10X) of Rolled-In Surface Defects in Titanium Plate Shown in Figure 3

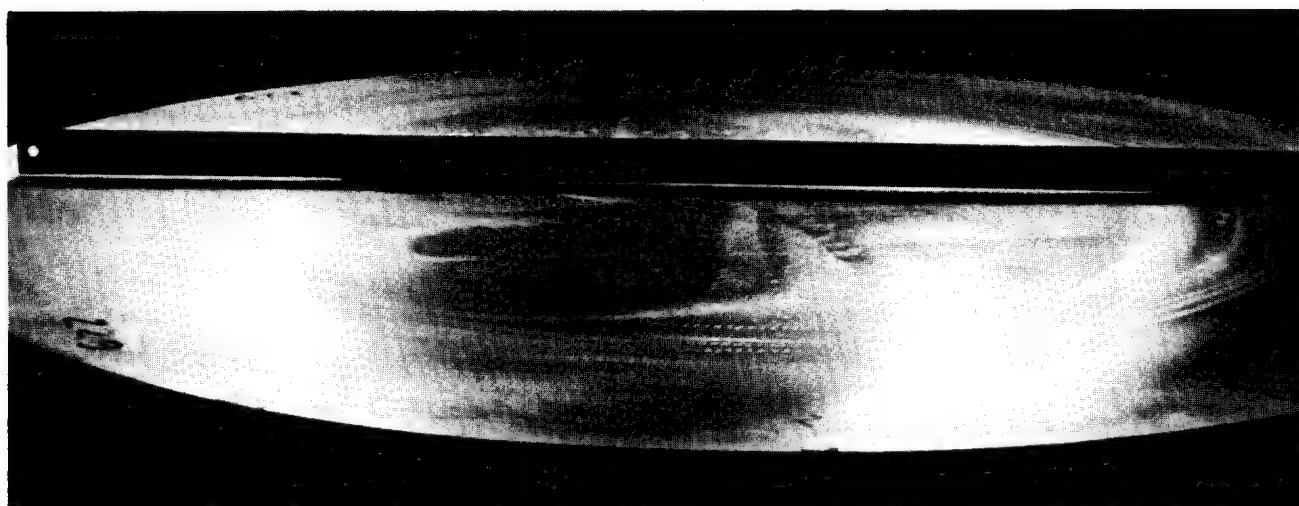
Figure 5 Explosive-Forming Blank (Same as Fig. 3 and 4) Illustrating Deviation From Flatness

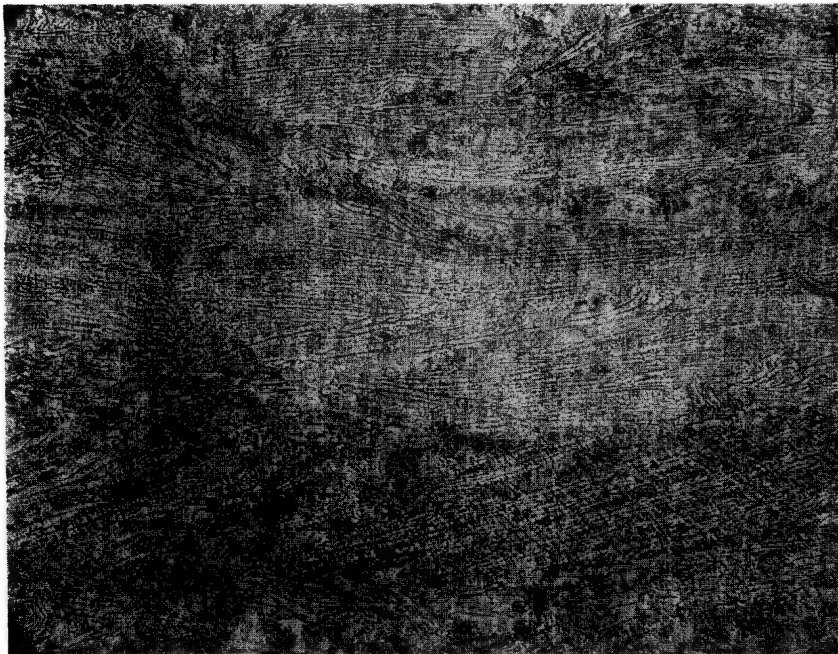
A metallurgical investigation as to the cause of failures was then undertaken. The normal cause for forming failures in titanium (a hard face-oxidized surface and contamination) was suspect. Investigation revealed that improper annealing by the producer rather than contamination was the cause. Mill records were studied and it was determined that one group of the plates had been annealed at 1500°F for 30 minutes and the second group at 1500°F for 15 minutes. While normal tensile tests did not reveal the lack of a proper anneal, the photomicrographs left no doubt as to the material condition. Photomicrographs (Fig. 7 and 8) show the heavily textured grain structure with no indication of alpha surface scale. All the formed domes listed in Tables 1 and 2 exhibited crosshatched microcracks (Fig. 9). The crosshatched microstructure automatically scrapped all domes that had been produced to this point even though they did not indicate conditions of surface cracking. The normal equiaxial grain structure for this alloy is shown in Figure 10.

Figure 7 Photomicrograph of Cross Section at 100X from Failure Area of Dome C-2 Showing Hot Roll Texture

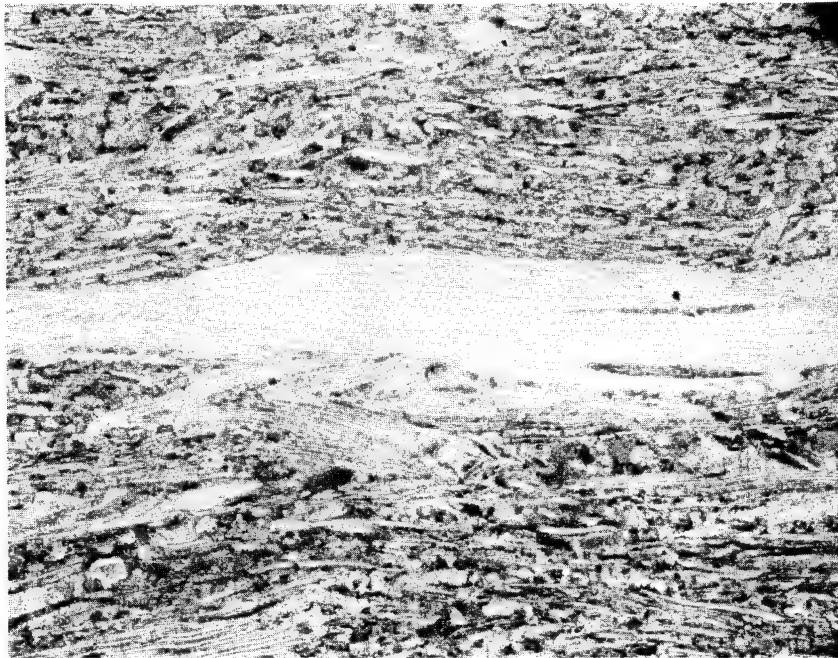
Figure 8 Photomicrograph of Longitudinal Cross Section at 100X of As-Received "C" Plate

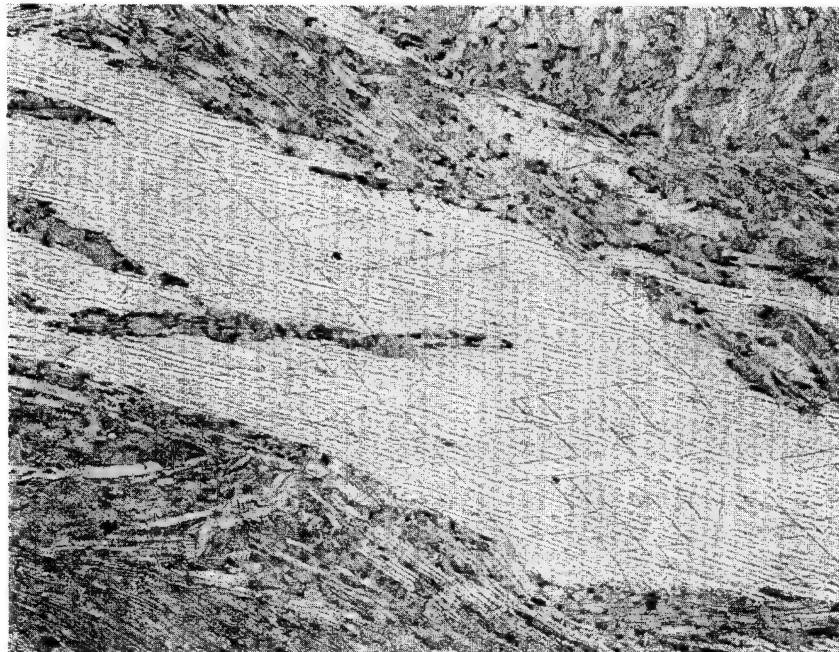
Figure 9 Photomicrograph of Cross Section at 100X from Failure Area of Dome D-3 Showing Crosshatch Cracking

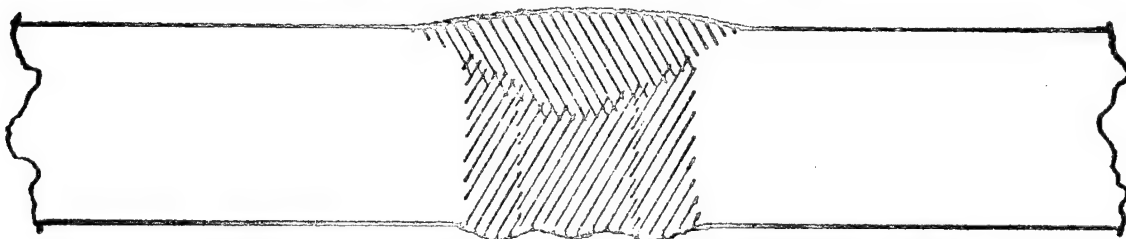
Electron Beam Weld Off  $\phi$  of Joint

Triple Pass Plus Cosmetic Pass

Figure 35 Defective Single-Pass Electron Beam Weld and Proper Triple-Pass Weld

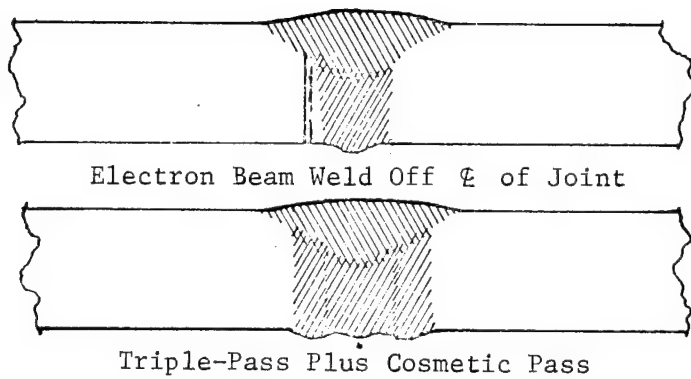
Figure 58 Defective Single Pass Electron Beam Weld and Proper Triple-Pass Weld

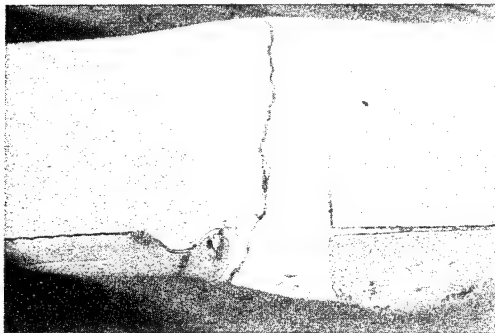
Figure 59 S/N 3 Failure in Girth Joint due to Weld Contamination

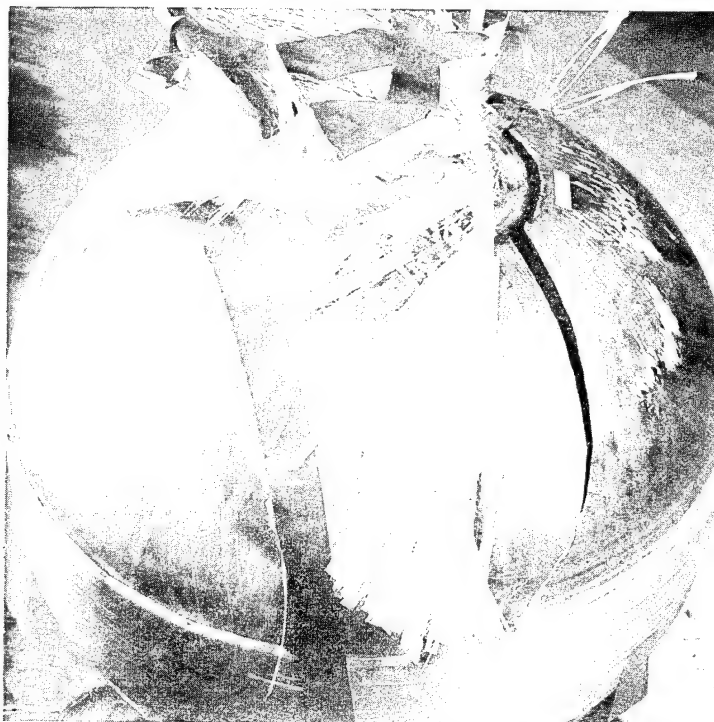
Figure 60 Photograph of S/N 4 Tank Showing Fracture After Removal of Fiberglass

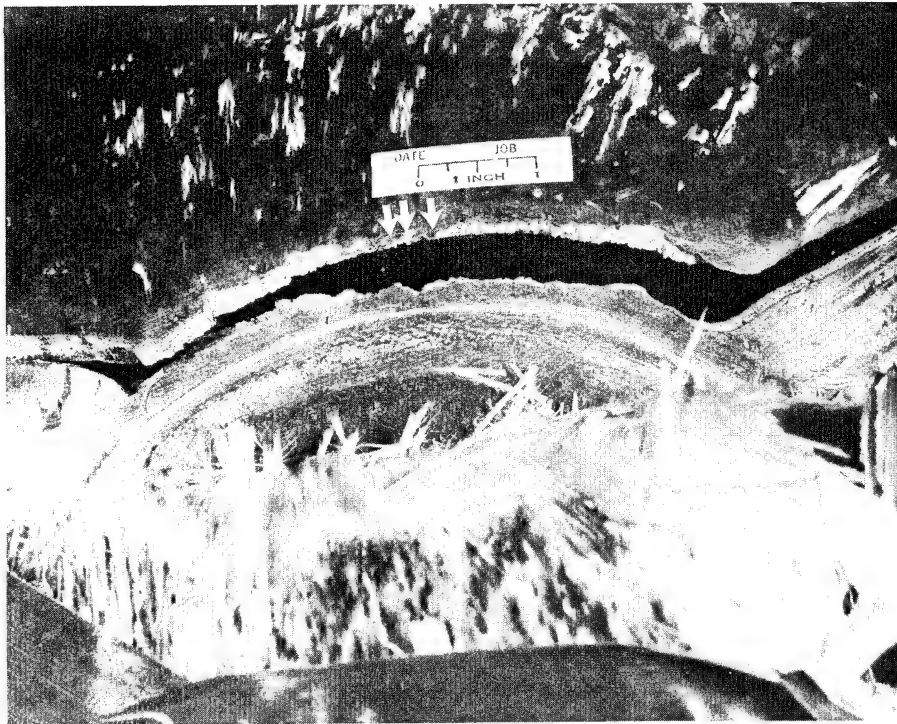
Figure 61 Photograph of S/N 4 Showing Weld Fracture  
With Arrows Indicating Approximate  
Origin of Failure

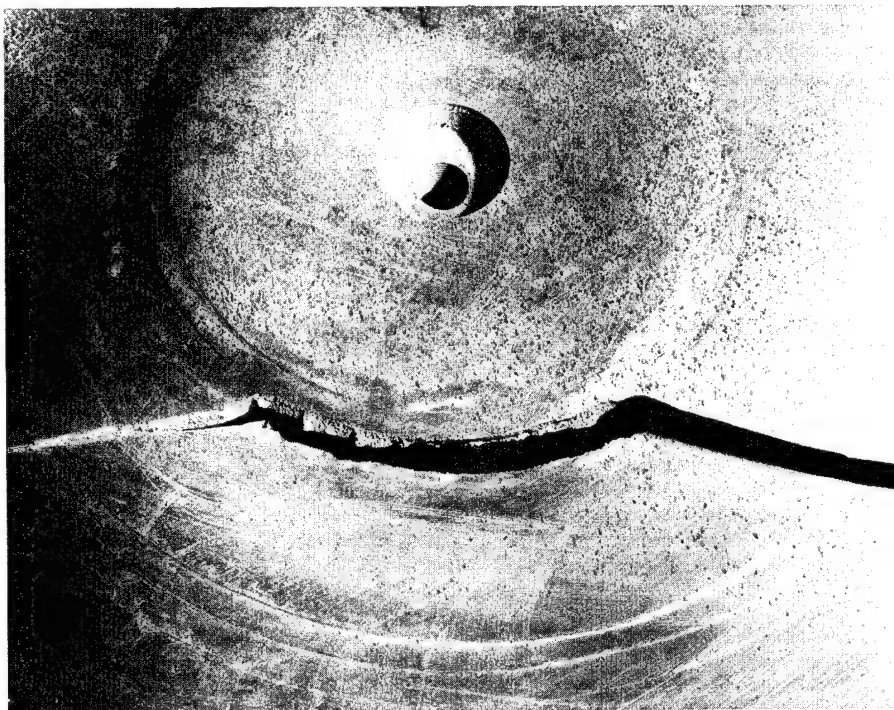
Figure 62 Photograph of S/N 4 Fracture from  
Inside the Tank

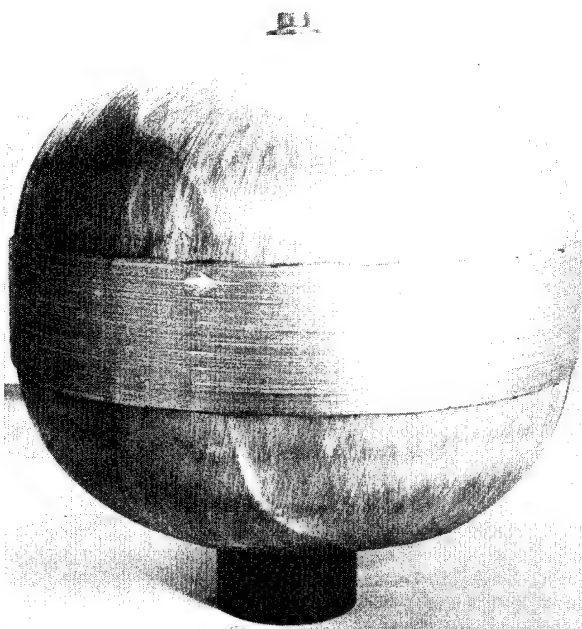
S/N 5 failed at 3660 psi during the hydrostatic sizing operation (Fig. 64). This is the only tank that failed in the longitudinal joint of the cylindrical band (Fig. 65). The failure area appeared to have been contaminated by an iron inclusion when a portion of the carry-through bolt that was a part of the weld tooling partially melted during welding. This was not detected by X-ray (Fig. 66).

Figure 64 Photograph of S/N 5  
Showing the As-Failed  
Configuration; Arrow  
Indicates Approximate  
Origin of Fracture

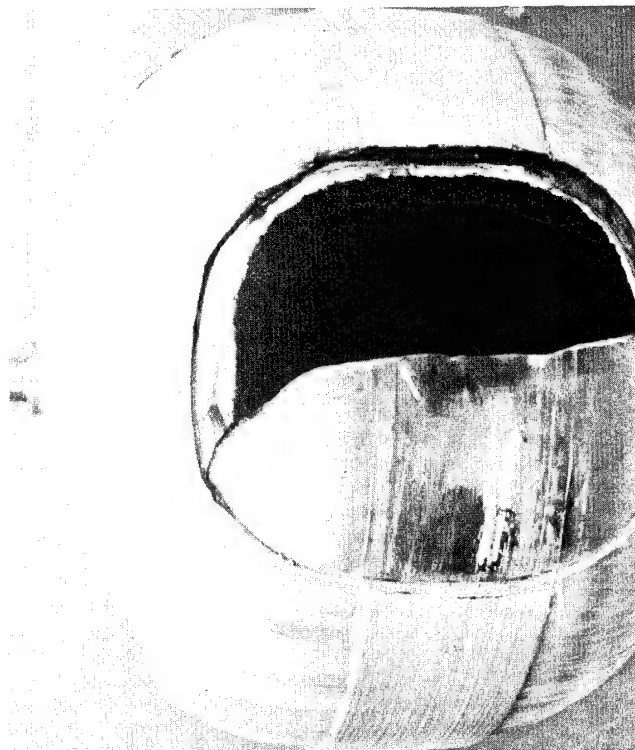
Figure 65 Photograph of S/N 5 Showing  
Exposed Fracture Surface;  
Arrow Indicates Failure  
Origin

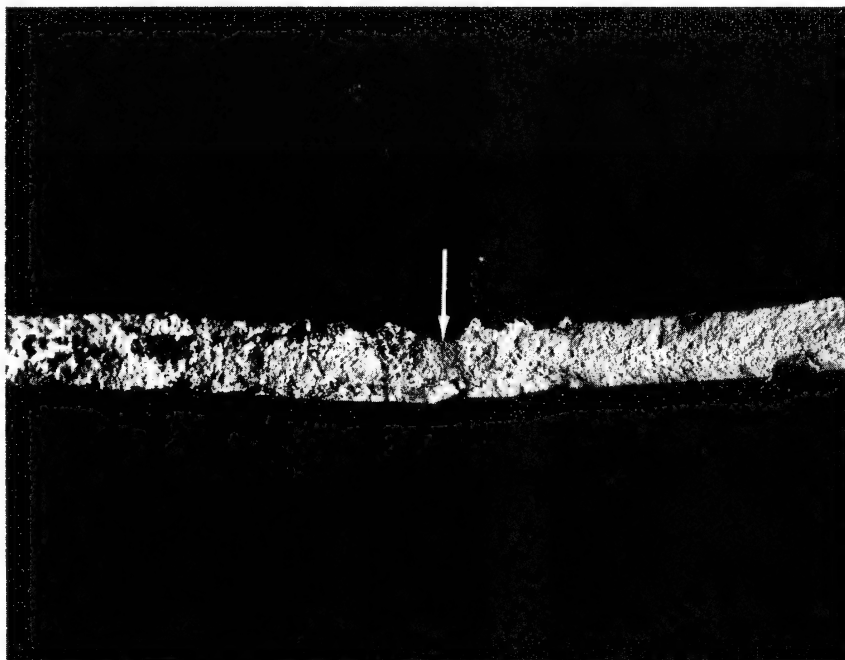
Figure 66 Photomicrograph of Fracture Surface on  
S/N 5; Arrow Shows Origin of Failure

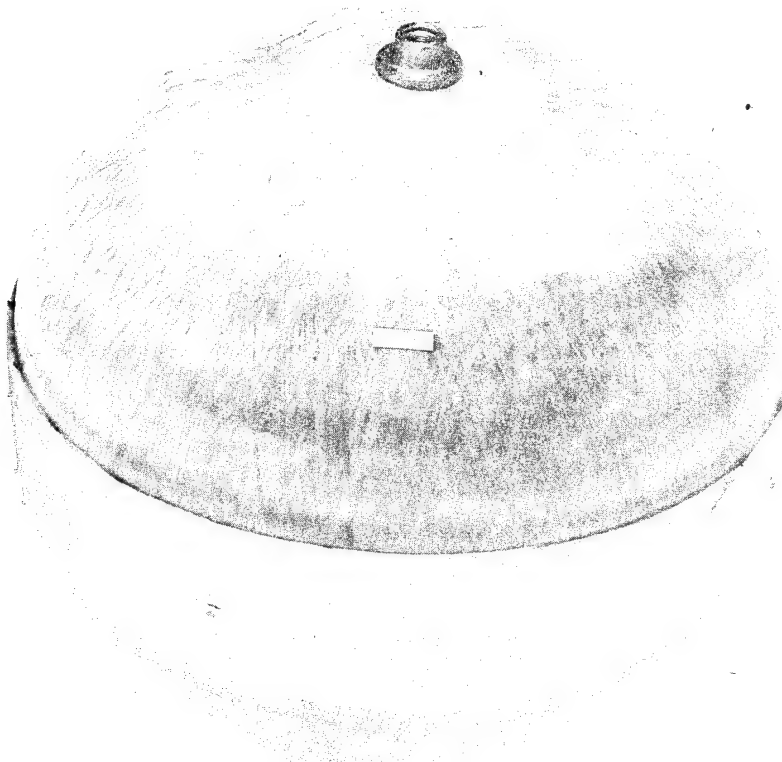
S/N 6 was successfully sized at 4527 psig. Following the hydrostatic sizing, it was checked for volume increase and then cycled at 75°F between 100 and 3360 psi. On the 49th cycle, there was an indication of a probable failure. On the 50th cycle a pressure decay of 21 psig/sec confirmed the failure and the test was stopped. Figure 67 shows the tank as failed and prior to the failure analysis.

Figure 6/ Photograph of S/N 6 Showing As-Failed Configuration

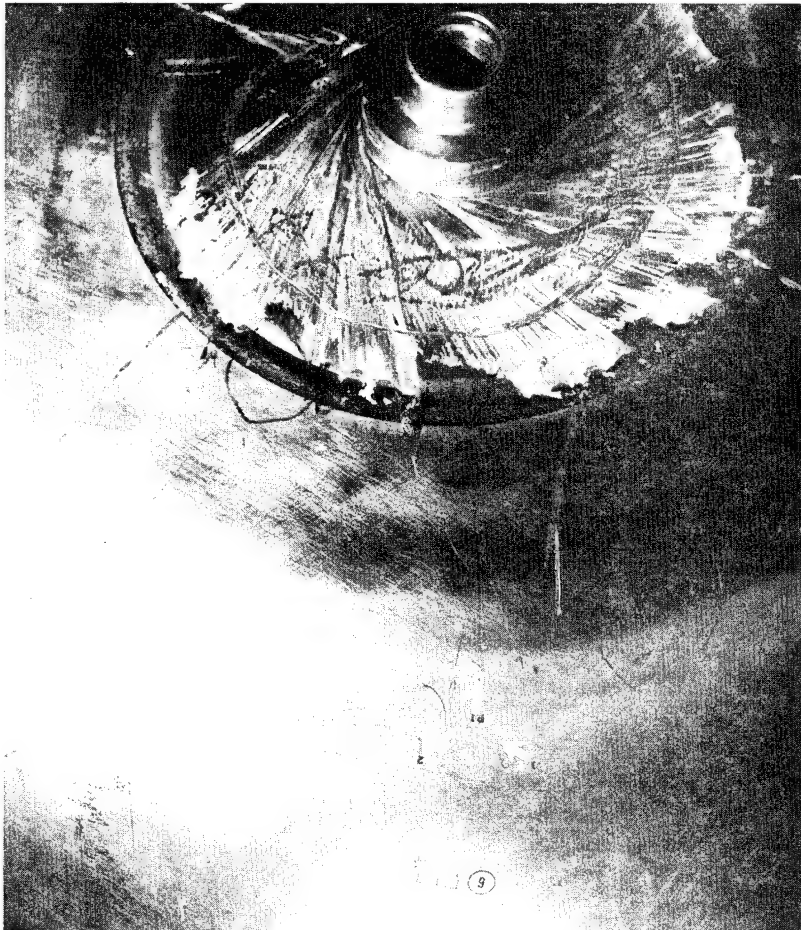
Figure 68 Photograph of S/N 6 Showing  
Leak Area

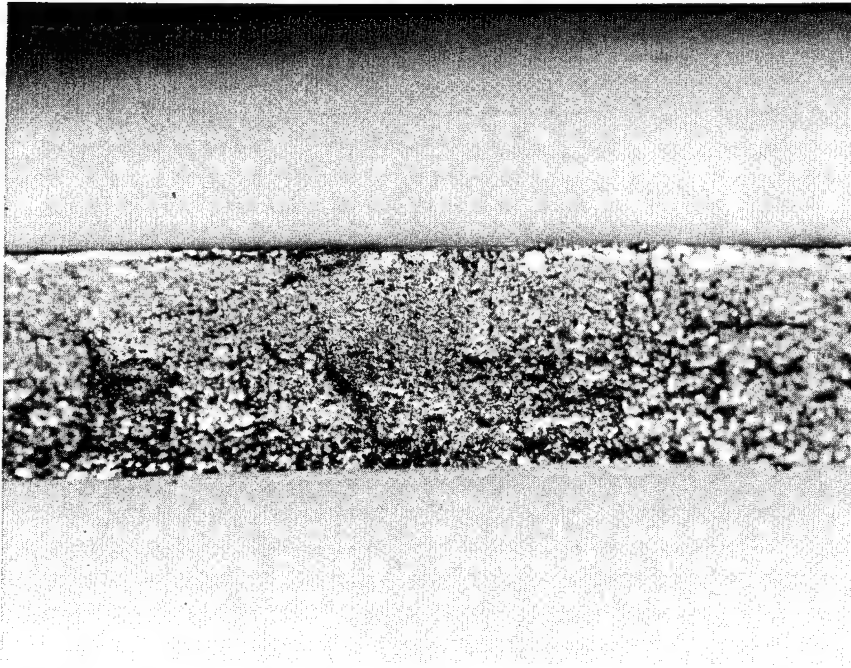
Figure 70 Cross Section of Failure Area on S/N 6  
Looking at End of Crack Shown on Figure 67

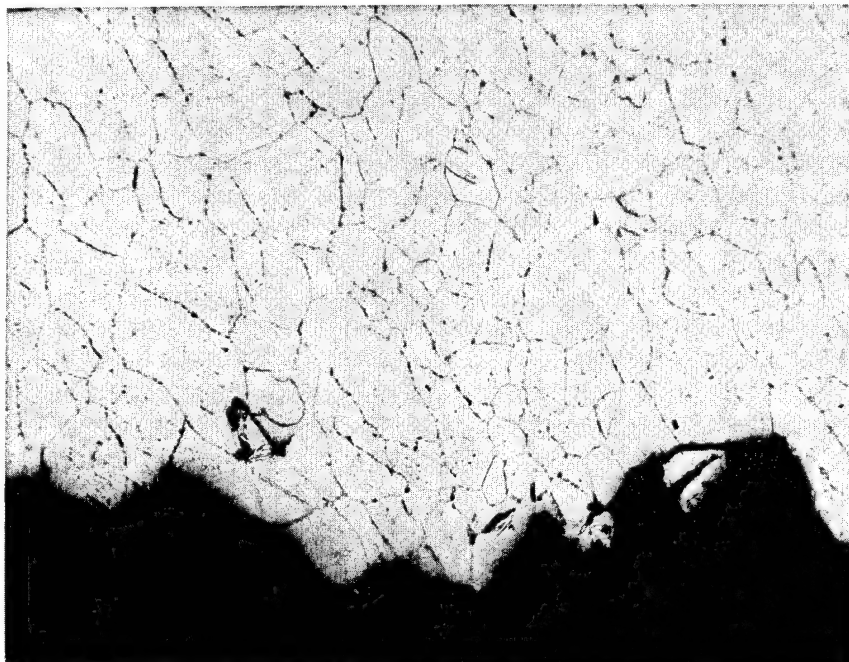
Figure 71 Section of S/N 6 Failure Looking at Edge  
of Fracture That Follows Grain Boundaries  
(Magnification, 250X)

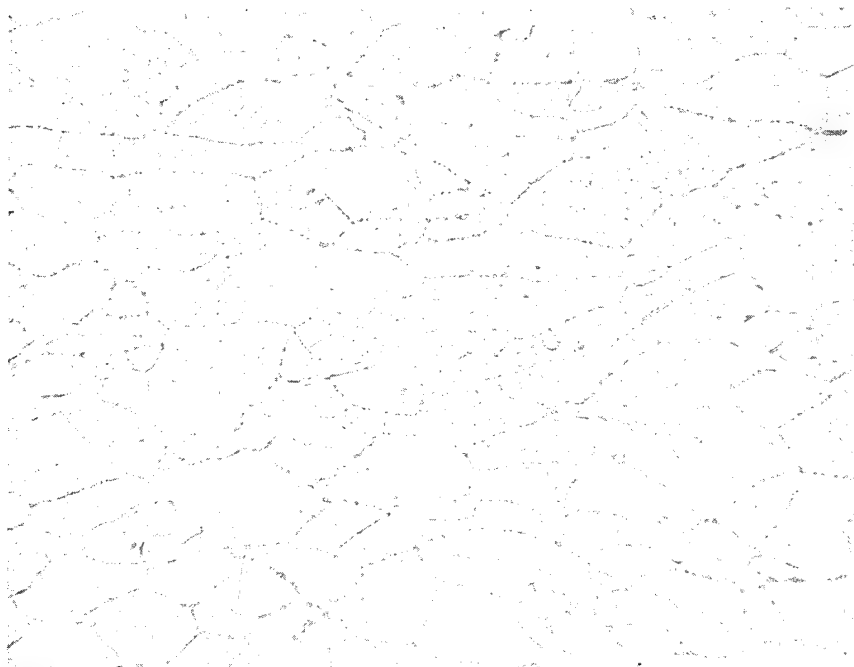
Figure 73 Photomicrograph of the Microstructure Through the Leak Area of S/N 6 (Note the "Dirty" Microstructure and Grain Boundary Precipitant, 250X)

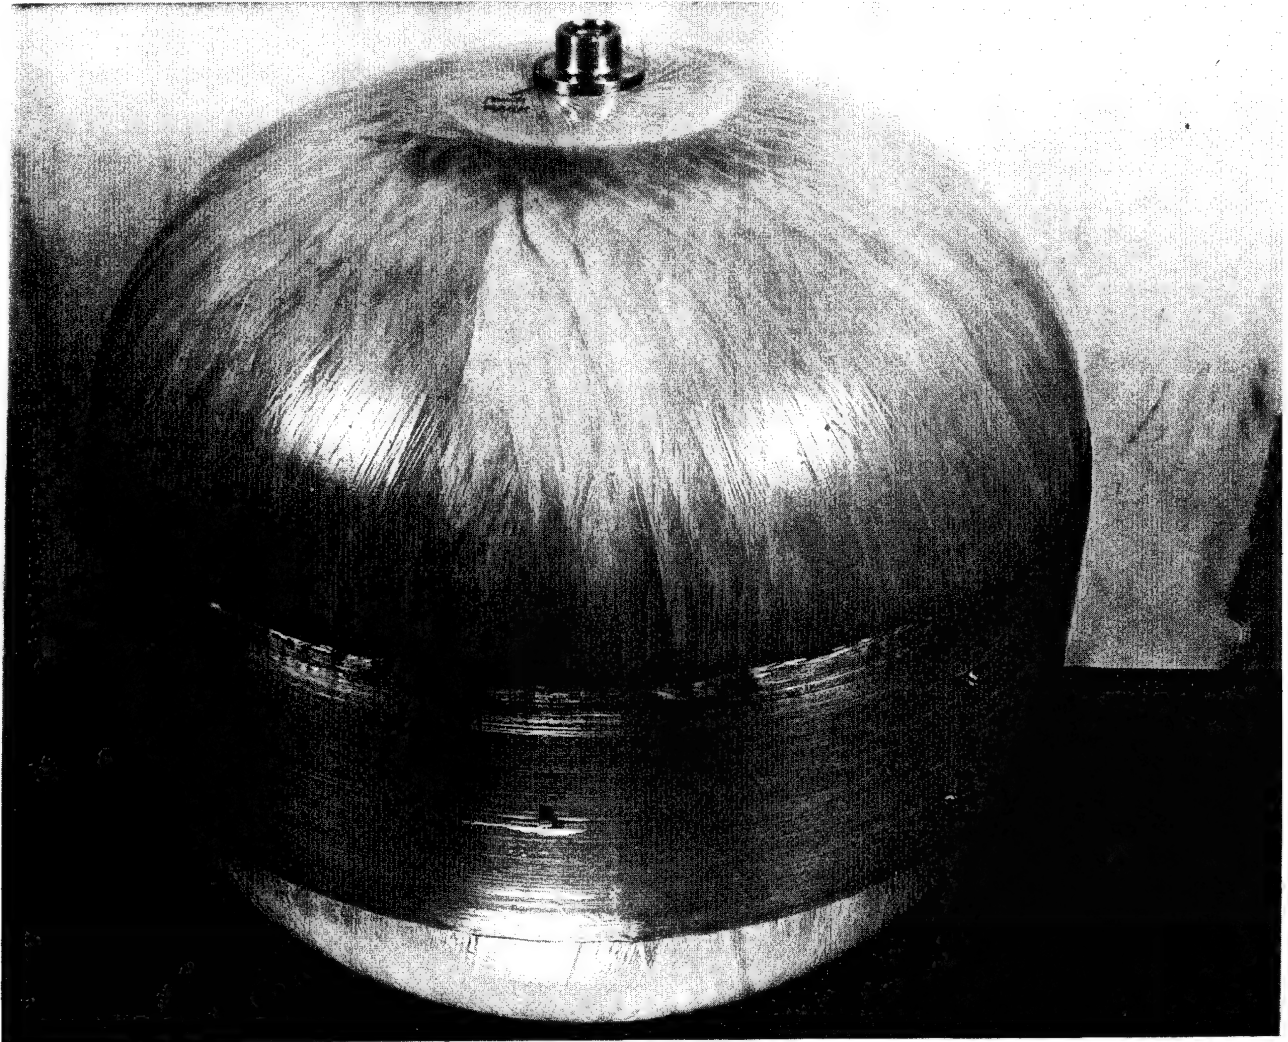
S/N 7 was hydrostatically sized at 4469 psig. The volume after sizing was determined to be 7327 in.<sup>3</sup> The vessel was then hydrostatically pressurized at 75°F to burst. The tank failed at 5062 psig (Fig. 74). The failure initiation point was in the girth weld. Analysis indicated the failure was due to simple overpressure with no metallurgical cause for failure.

Figure 74 S/N 7 after Failing at 5062 psi (Note the Lack of Fragmentation or Shattering of Overwrap Material)

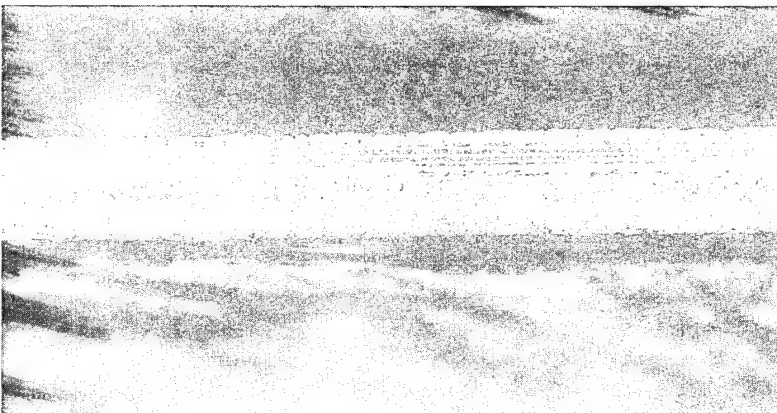
S/N 8 failed prematurely during hydrostatic sizing at 3432 psig (Fig. 75). The initiation point appeared to be at the dome-to-end fitting joint as indicated in Figure 76 and was due to lack of fusion (Fig. 77).

Figure 77 Photomicrograph of S/N 8 Fracture Surface Showing Lack of Fusion at Dome-to-Fitting Joint

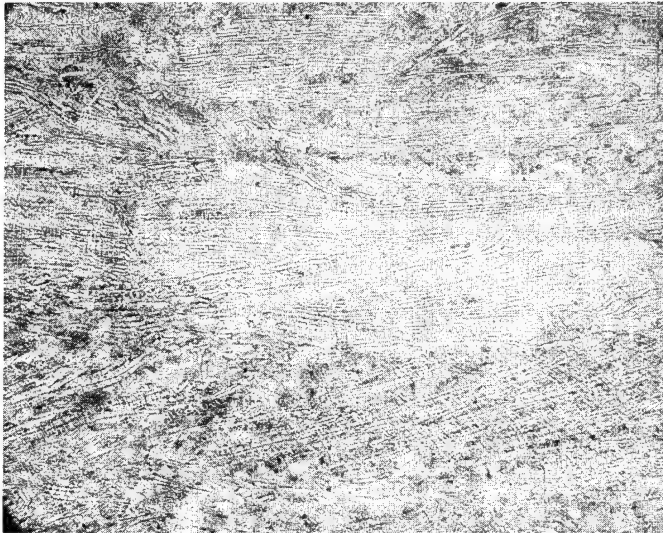
Microexamination of cross sections taken from the failed areas of the two domes C-2 and D-3 revealed no evidence of alpha scale. The microstructure was predominantly hot-rolled-textured (Fig. 1). Several areas of crosshatch cracking were observed in the microstructure near the failed areas (Fig. 2).

Figure 1 Photomicrograph of Cross Section at 100X from Failure Area of Dome C-2 Showing Hot-Roll Texture

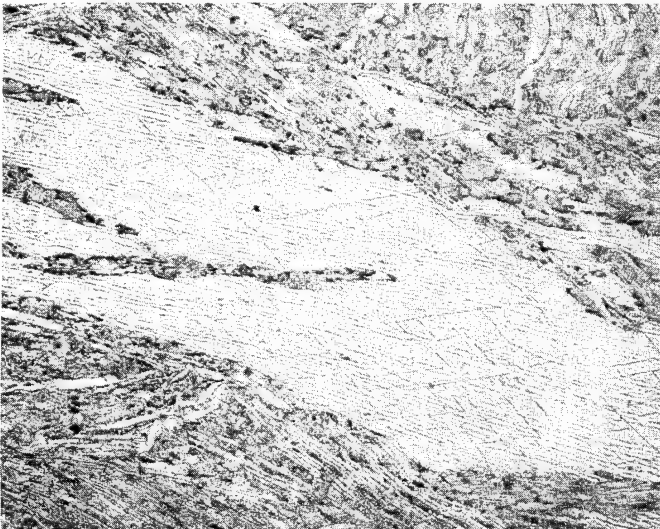
Figure 2 Photomicrograph of Cross Section at 100X from Failure Area of Dome D-3 Showing Crosshatch Cracking

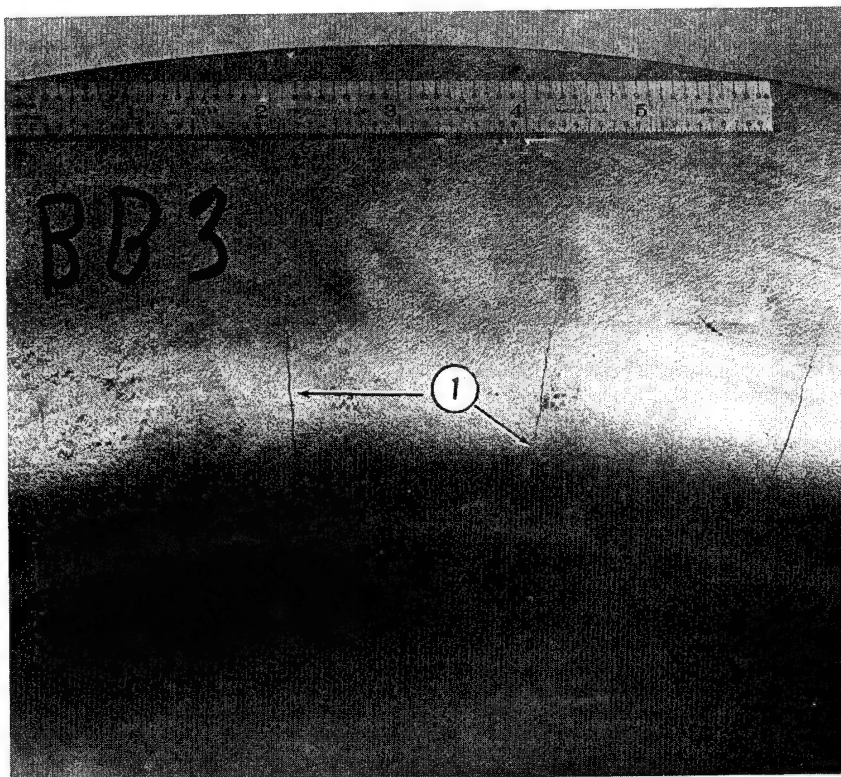
Macroexaminations of the eight cracked domes and specimens from four domes, as-received materials, and as-annealed stock were conducted. In summary, these examinations indicated that an oxygen-rich (stabilized alpha) case was developing on both the inside and outside surfaces of the domes, and that stress corrosion cracking was occurring in some domes. Buckling and stress rupture have not been eliminated as possible causes for the cracks near the apexes of the domes.

Figure 1 Cracks in the Flange Radius of Dome BB3

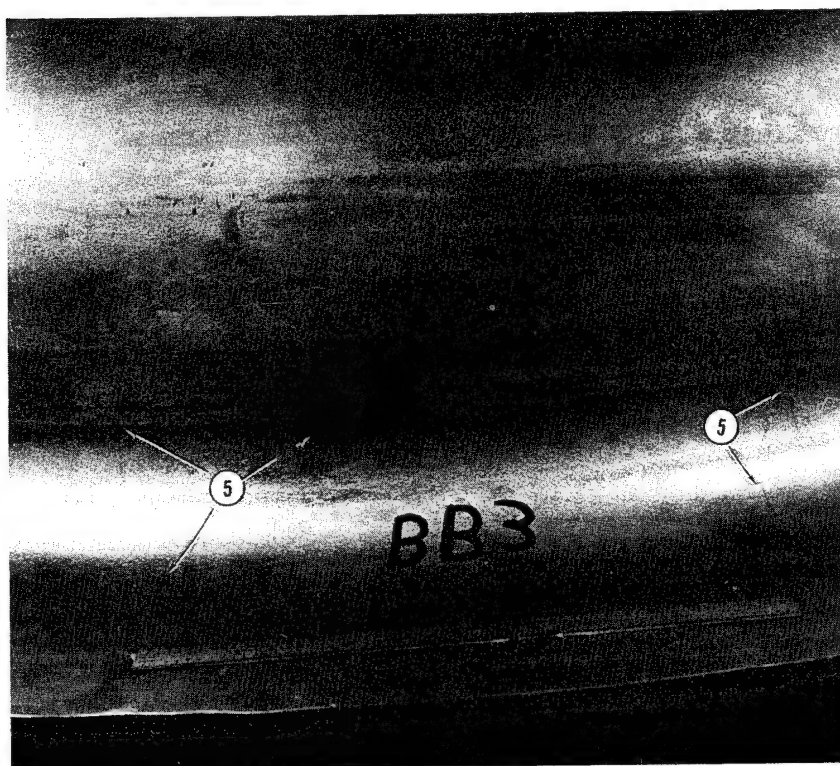
Figure 2 Cracks in the Flange and above the Flange of Dome BB3

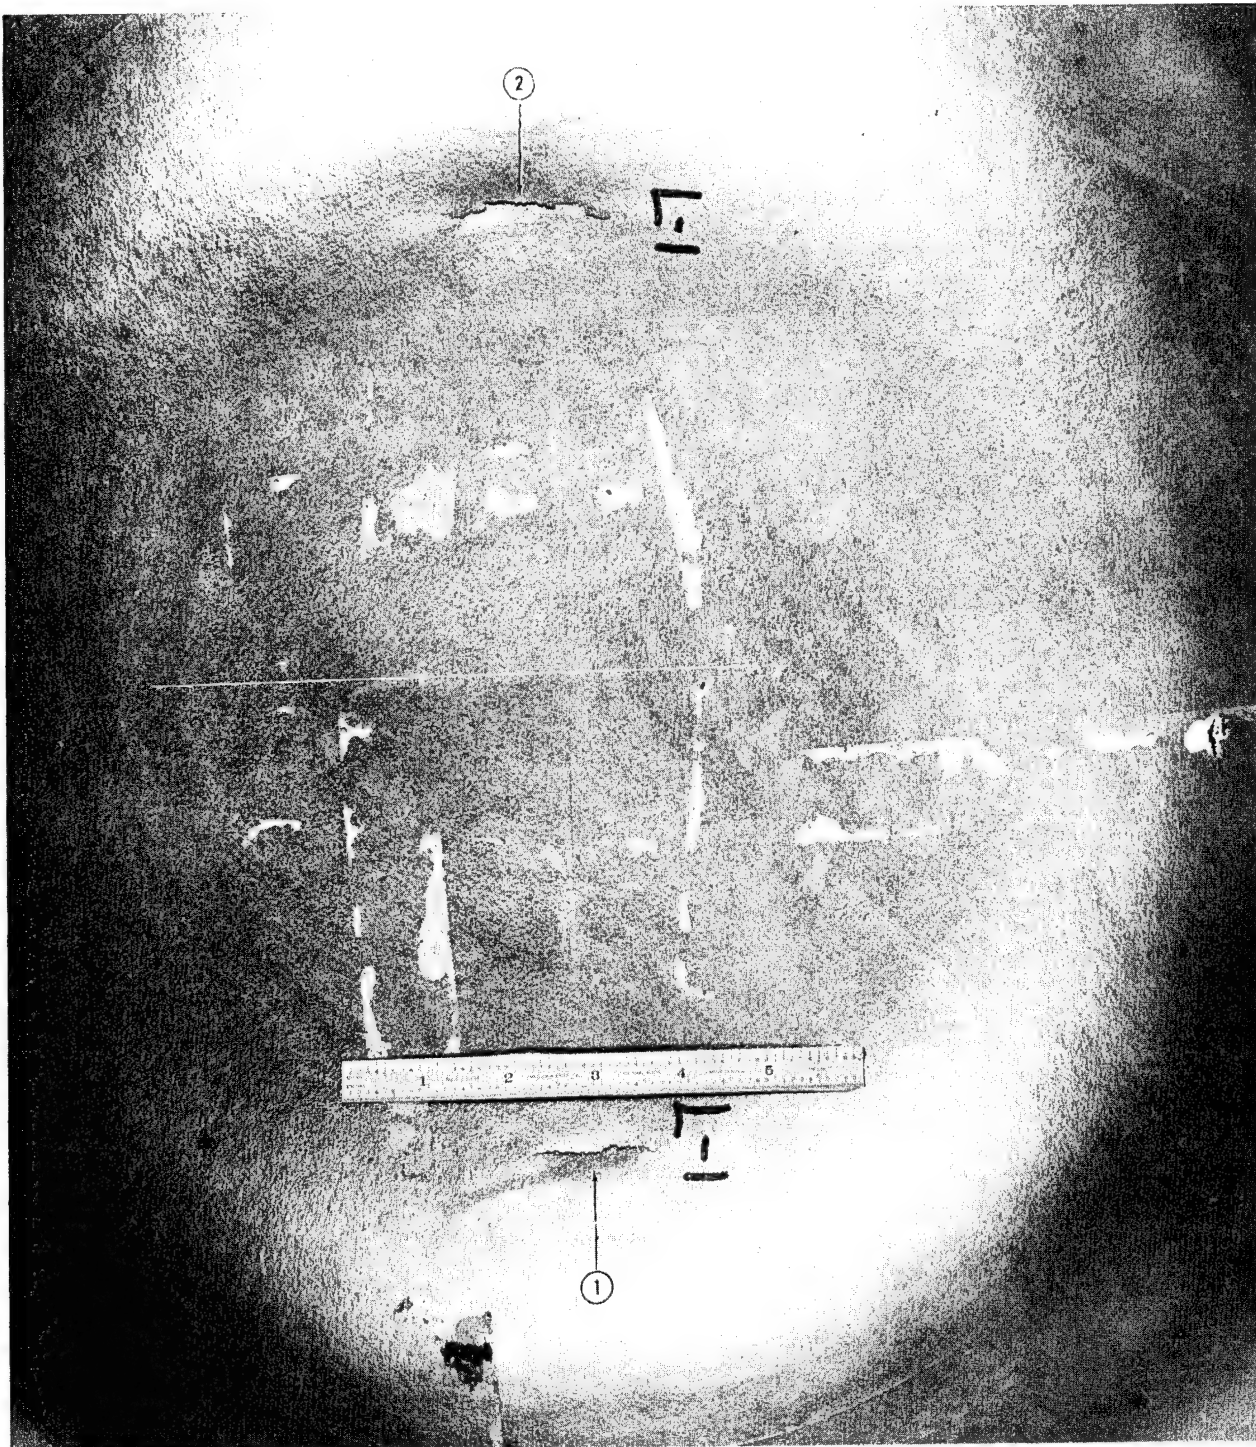
Figure 5 Cracks on the Inside Surface Near the Apex of Dome L1
